Boondooma Homestead, 8262 Mundubbera–Durong Road Conservation Management Plan

Prepared for Boondooma Museum & Heritage Association Inc.

June 2022—FINAL

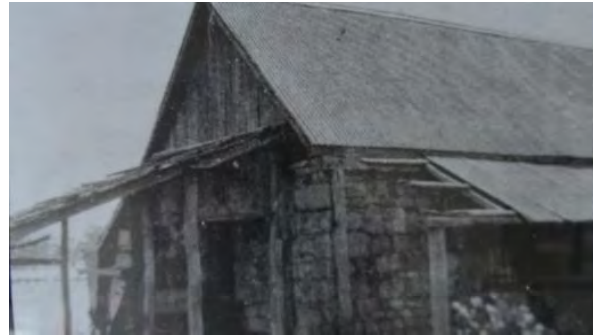
Figure 21. The stone store building c.1949, with the remnants of the timber 'butcher's shop' attached to the south-western façade. *Source:* Boondooma Museum & Heritage Association (2021).

Note: This image illustrates the early lean-to verandah additions to the long and short sides of the stone store building, which are in a deteriorated condition here in the mid-twentieth century.

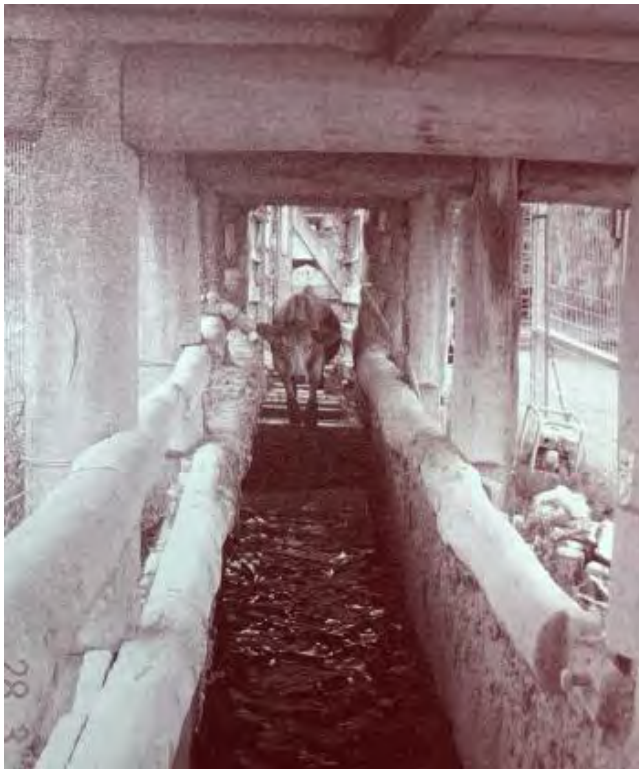
Figure 27. A heifer entering the Boondooma cattle dip, noting the unique construction of very thick layers of impervious clay bounded by hardwood slabs to create a channel. *Source:* DPI (2002, 22).

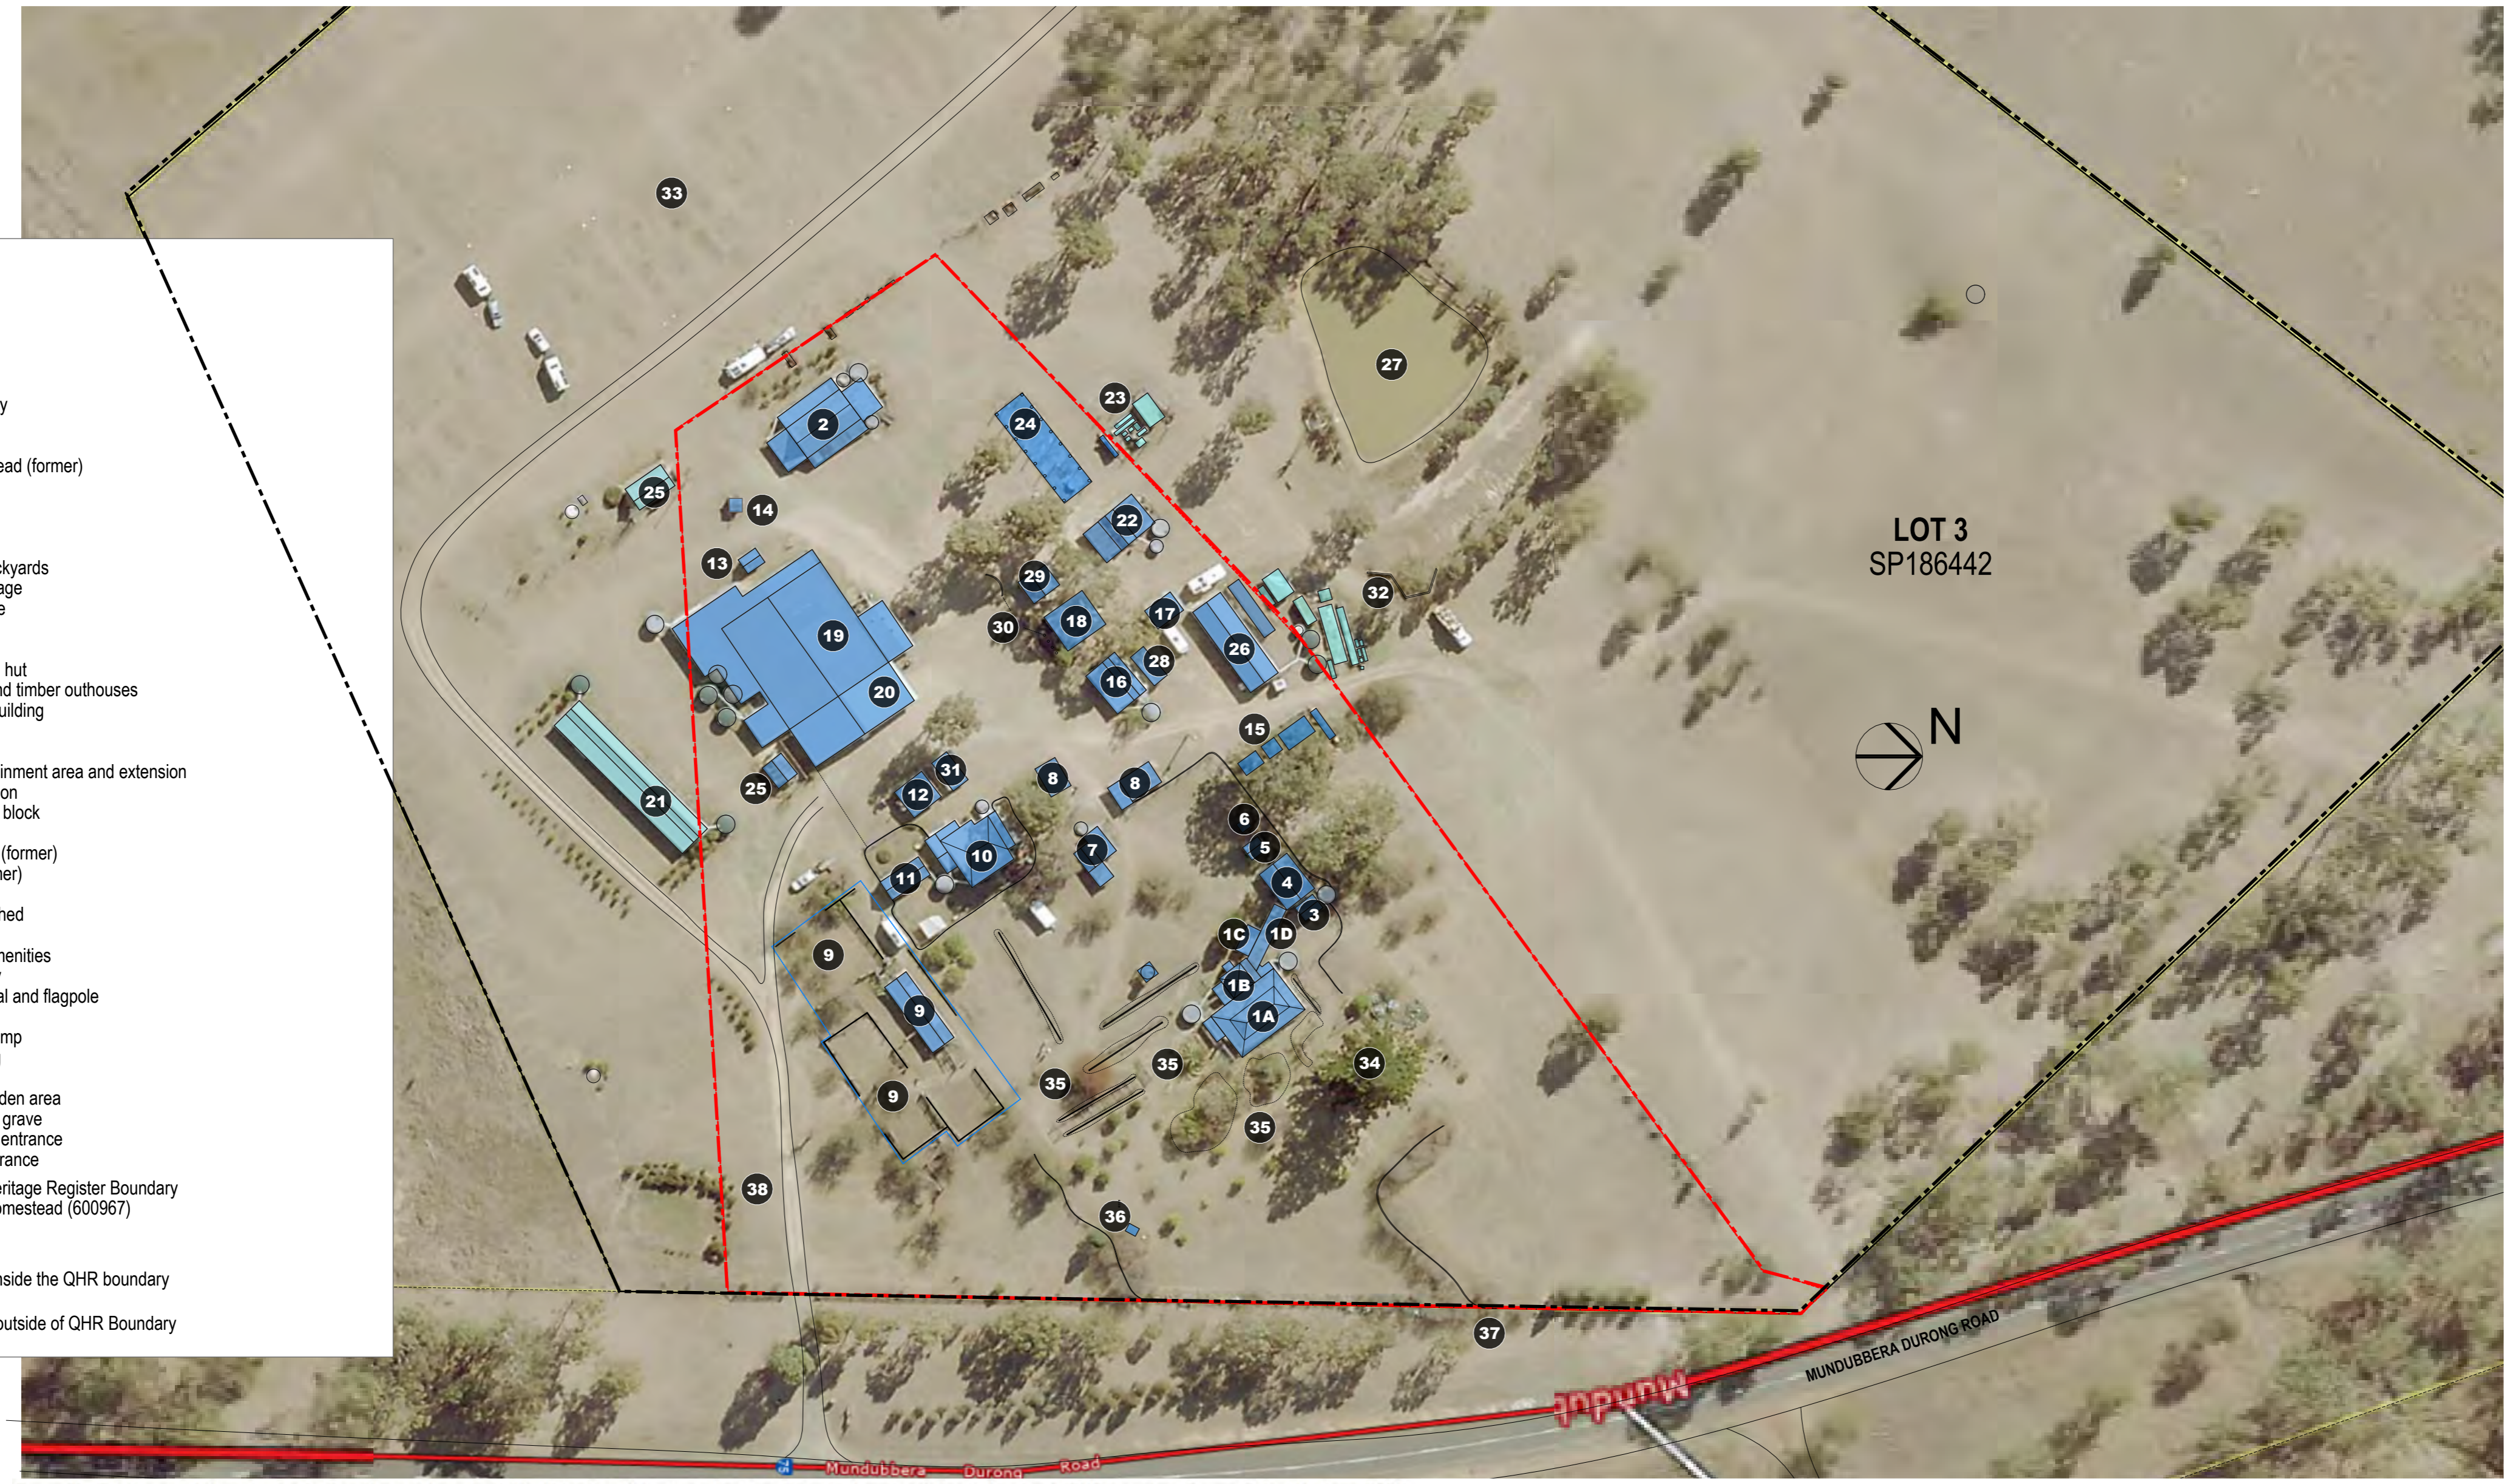
Figure 55. Existing aerial view site plan for Boondooma Homestead, identifying the site's principal and ancillary structures in relation to the place's QHR boundary. Source: Extent Heritage (2021).

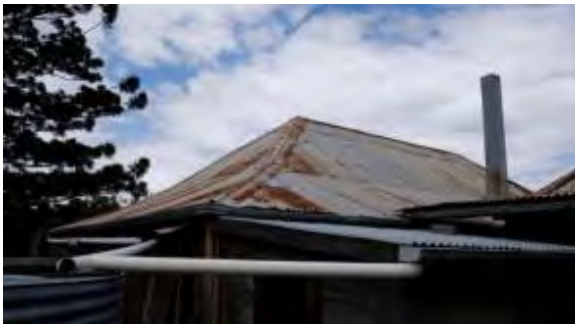
Figure 86. View facing north-east showing the 'broken back' roof profile of the main homestead, and the skillion-roof of one of the small extensions.

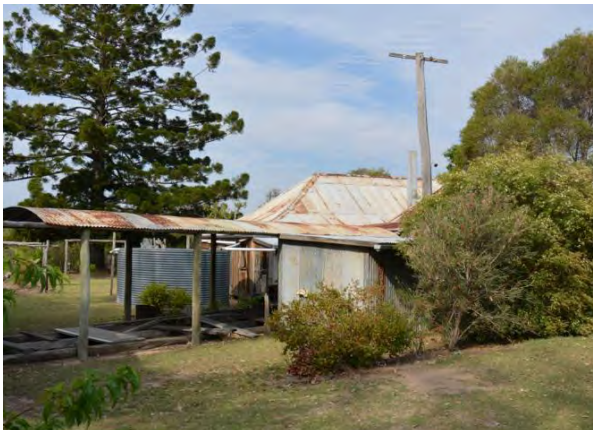
Figure 87. View facing north-east showing covered walkway, constructed of a post-and-sapling frame with a corrugated iron roof, connected to the main homestead.

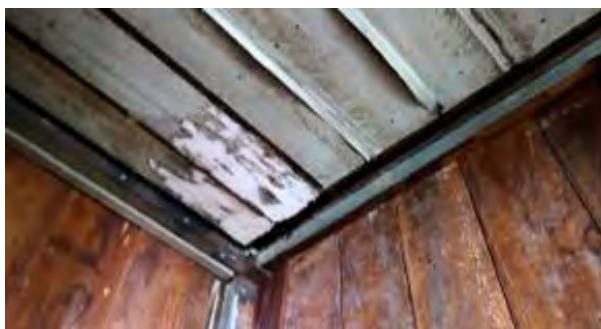
Figure 112. Detail of the north-west corner of the ceiling in Bedroom 2, showing water penetration affecting the ceiling, and movement at wall and ceiling junction.

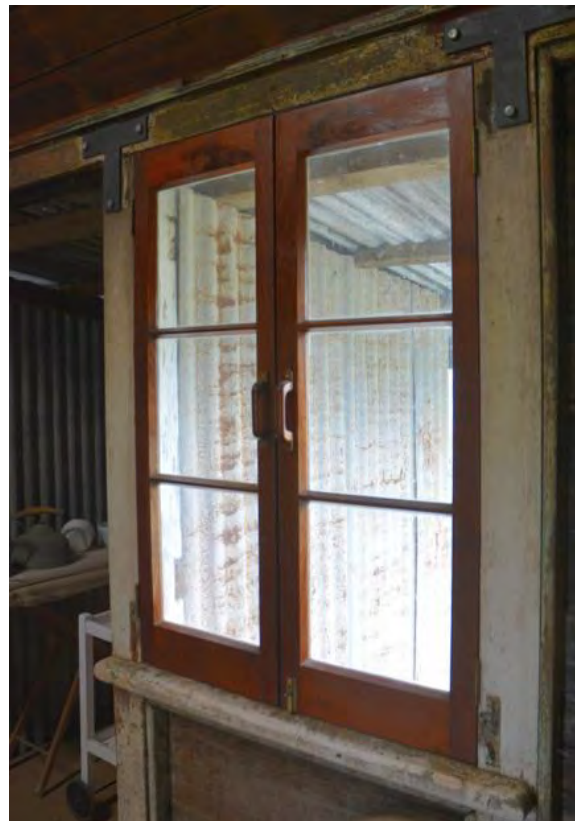
Figure 125. Example of the replacement timber casement windows in the kitchen, which are non-sympathetic additions.

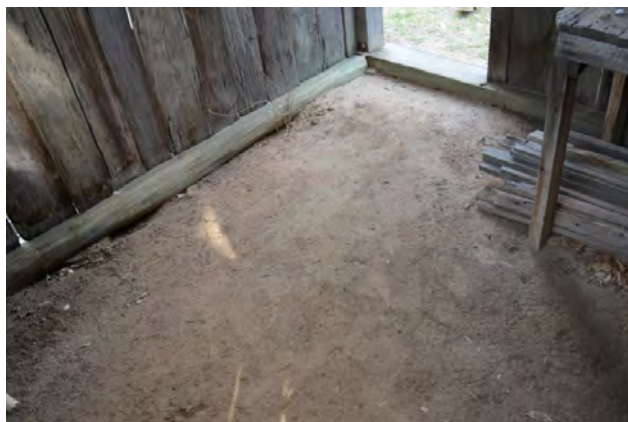
Figure 154. Interior of the meat house showing the compacted earth floor.

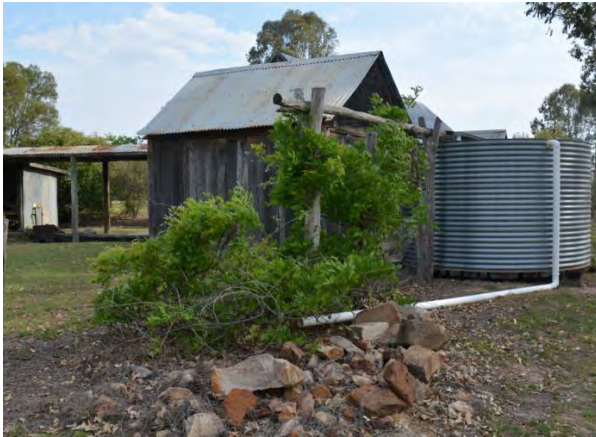
Figure 155. View facing south-west of the meat house, showing the adjacent water tank and timber trestle supporting the rainwater goods.

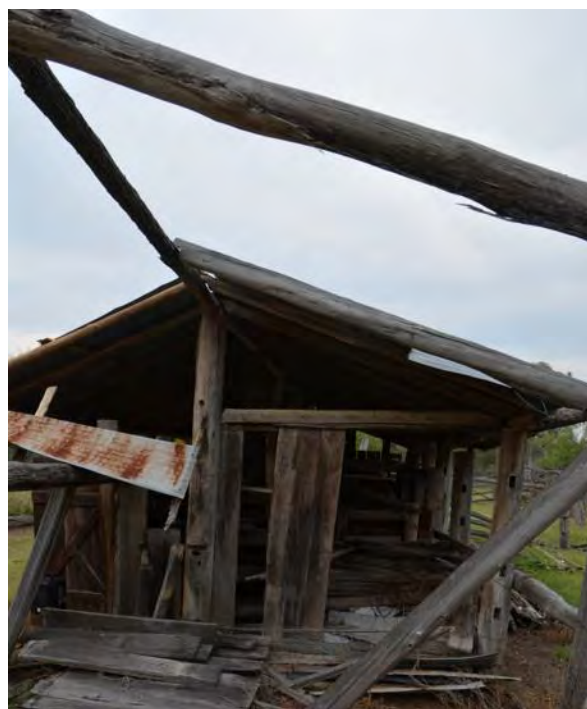
Figure 188. The north-eastern end of the milking bails structure, which is substantially deteriorated.
